Manhole Inspection Summary

Manhole # S39MM_029MH

Insp Date: **2/5/07 2:14 PM**

Location Address: **1919 KENNEDY AVE**

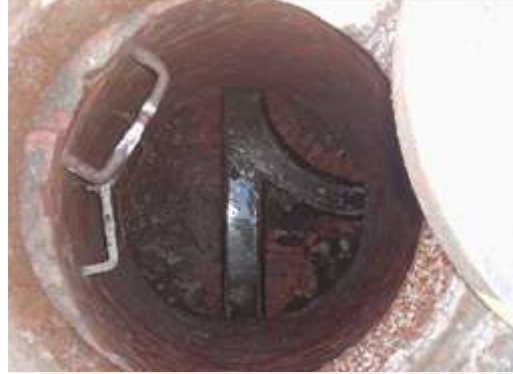
Top View

Corroded steps. Bench and Channel debris.

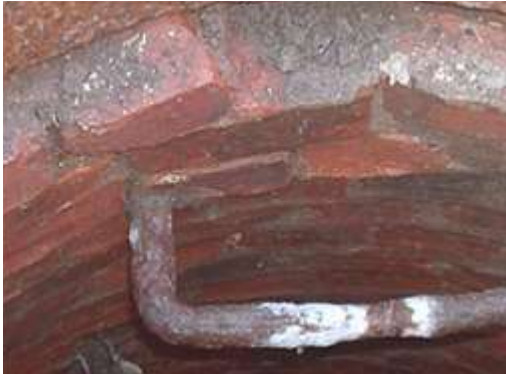
Defect

Offset: **2** (in.)

Condition: ☐ Sound ☐ Cracked ☐ Root Intrusion ☐ Loose Brick ☒ **Deteriorated**

Infiltration: ☐ None ☒ **Joint** ☐ Cracks ☐ Mortar ☐ Roots ☒ **Wall**

Frame offset. Adjustment deterioration and infiltration.

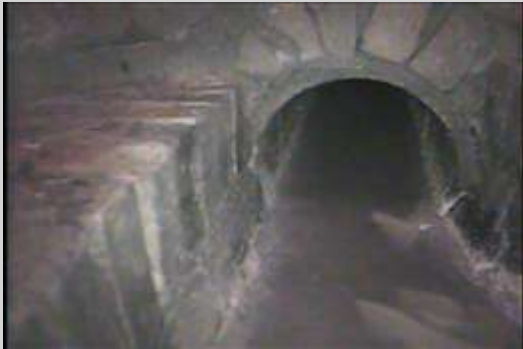
8 in. Circular Gravity Sewer Pipe Out @ 12 O'Clock

Invert Depth: **9.00** (ft.) Flow Characteristics: **Slow**

Deposits: ☐ None ☐ **Mud** ☐ Sludge ☐ Debris ☒ **Grease**

Silt Depth: **0** (in.) Deposits Extent: **Light**

Infiltration: **Evidence** Pipe Seal Cond: **Unknown**

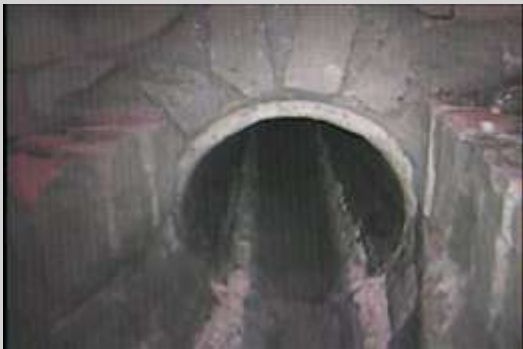
8 in. Circular Gravity Sewer Pipe In @ 3 O'Clock

Invert Depth: **8.92** (ft.) Flow Characteristics: **Slow**

Deposits: ☐ None ☐ **Mud** ☐ Sludge ☐ Debris ☒ **Grease**

Silt Depth: **0** (in.) Deposits Extent: **Light**

Infiltration: **None** Pipe Seal Cond: **Unknown**

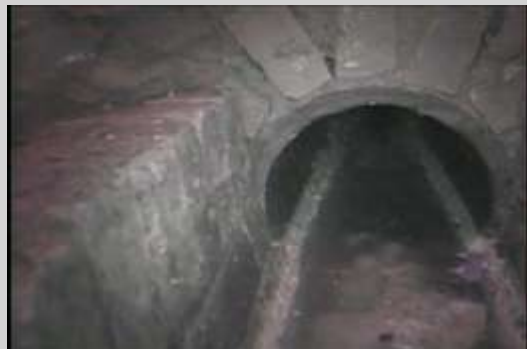
8 in. Circular Gravity Sewer

Invert Depth: **8.94** (ft.) Flow Characteristics: **Slow**

Deposits: ☐ None ☒ **Mud** ☐ Sludge ☐ Debris ☒ **Grease**

Silt Depth: **0.5** (in.)

Infiltration: **Evidence**
